# **SITE SUITABILITY AND NATURAL HAZARD REPORT**

**Ongaroto Road  
Subdivision, Whakamaru**

**19 FEBRUARY 2023**

PROJECT NO. C2131

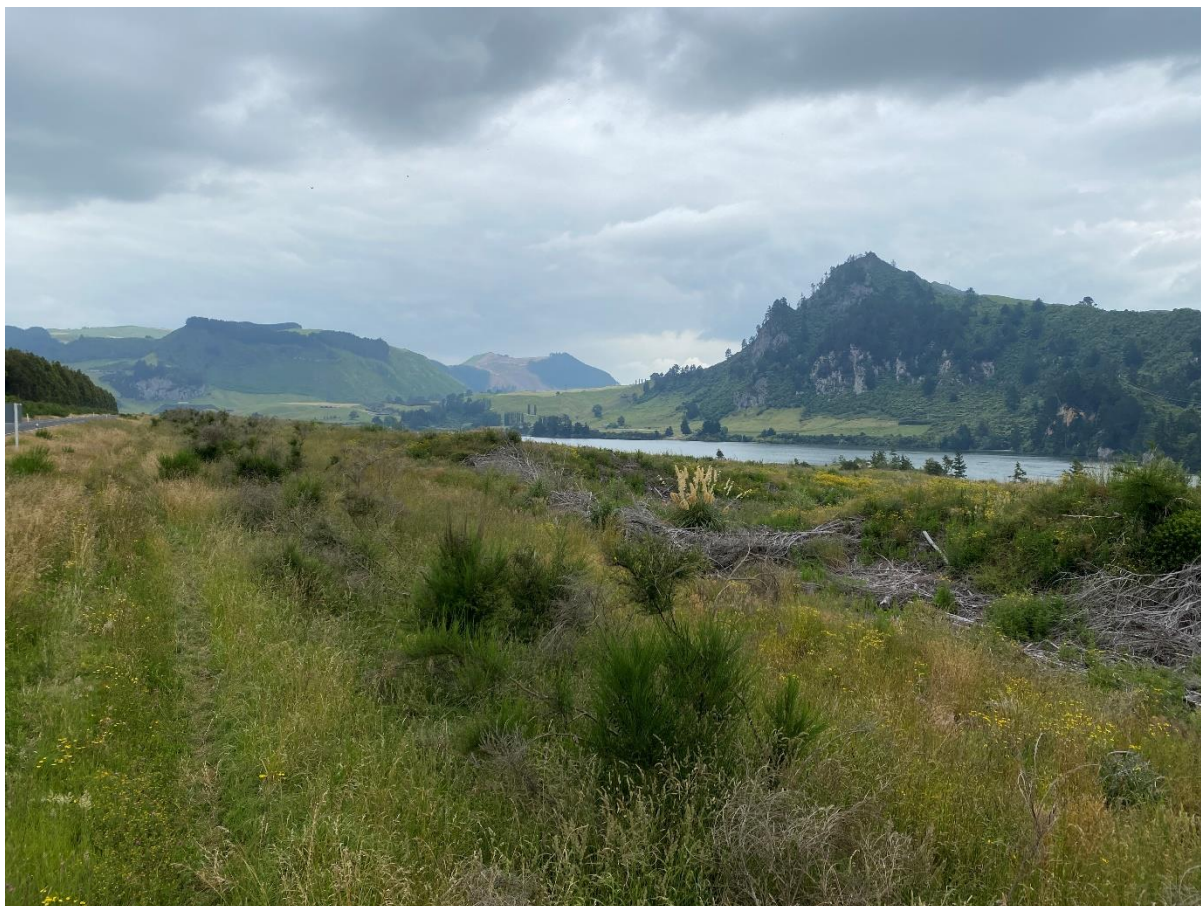
Figure 1: Site Photo

It is noted that on a second site walkover on the 12<sup>th</sup> of October 2022 much of the site had been cleared and new pine saplings had been planted. The clearing of the site highlighted areas used as skids for forestry and showed the metal at the surface. It also showed that at the surface in some locations are boulders and rock outcrops. The lower south-eastern portion of the site directly adjacent to the lake and local reserve had shown areas of recontouring.

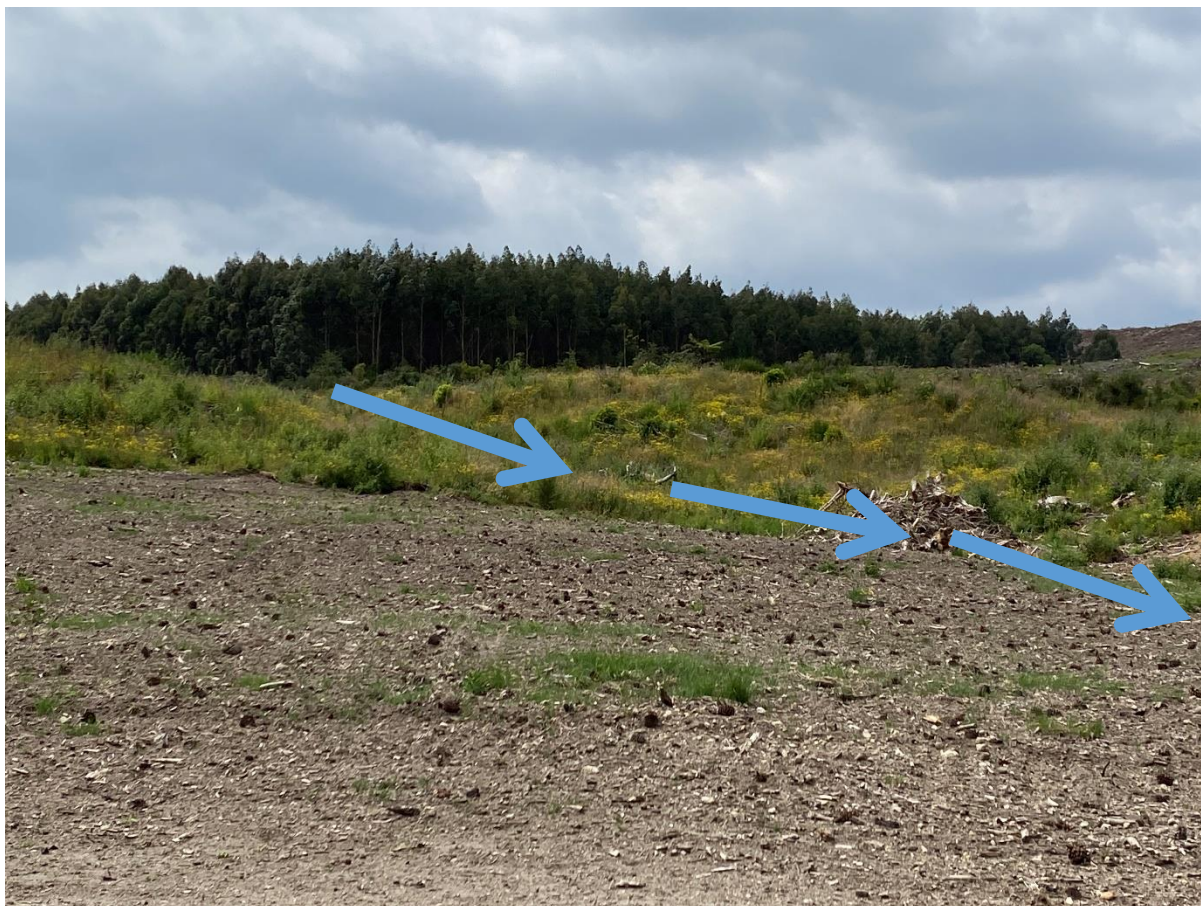
There are no significant water courses or gullies on the site. However, the Waikato River (Whakamaru Lake / Reservoir) sits near the site to the south, west and east. The site is elevated from the river and has a small buffer strip of council land between them the site and the river. There was one noticeable overland flow path on the site which was dry on the day of inspection but which is expected to hold water in times of extended rain fall. This is shown in Figure 2.

Figure 2: Small overland flow path (Blue) found in the field.

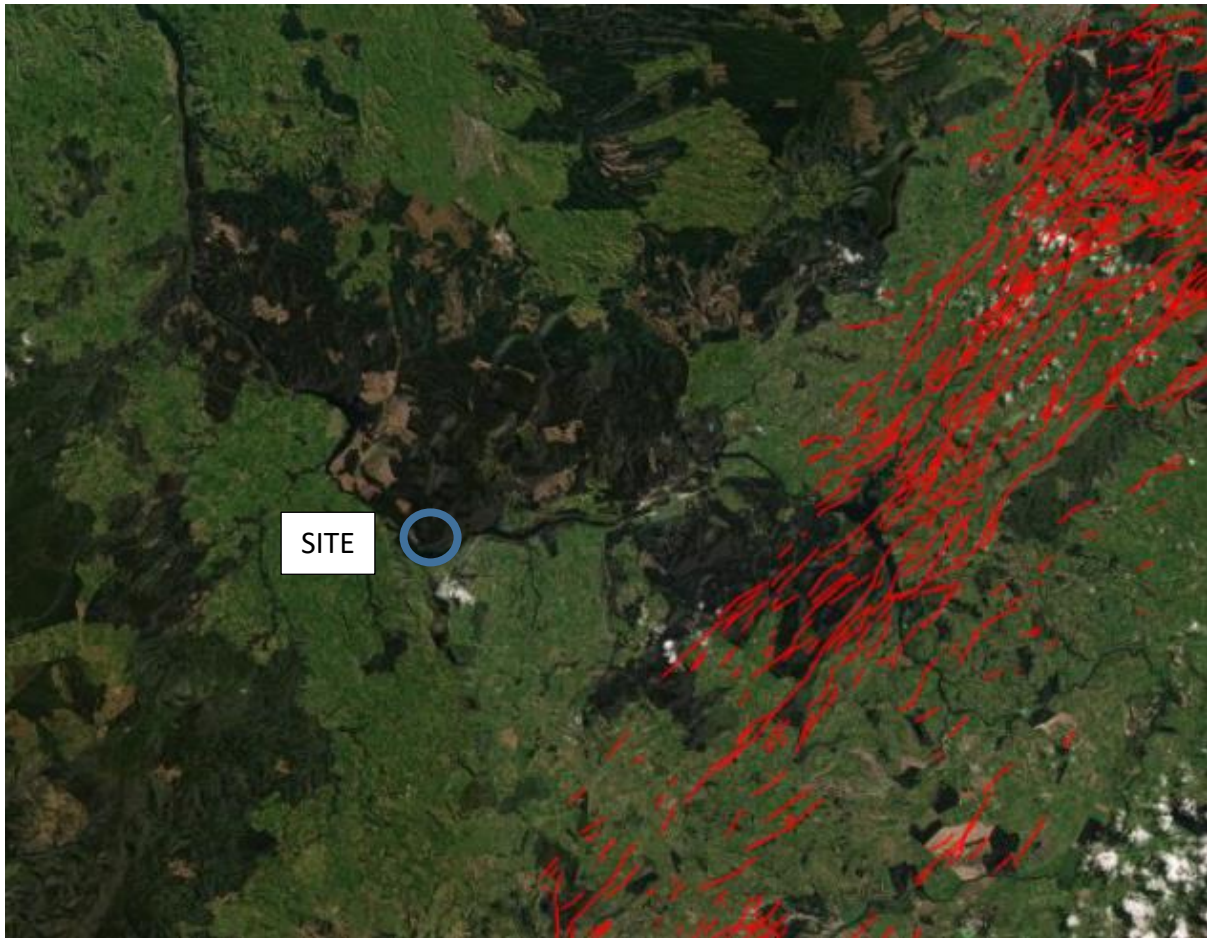
According to the GNS Science New Zealand Active Faults Database, the nearest known active faults are to the east. These are approximately 17km away. These are noted as being (generally) normal faults and form an extensional rift zone within the Taupo Volcanic Zone and are displayed in Figure 3.

Figure 3: Active faults near the proposed subdivision (red).

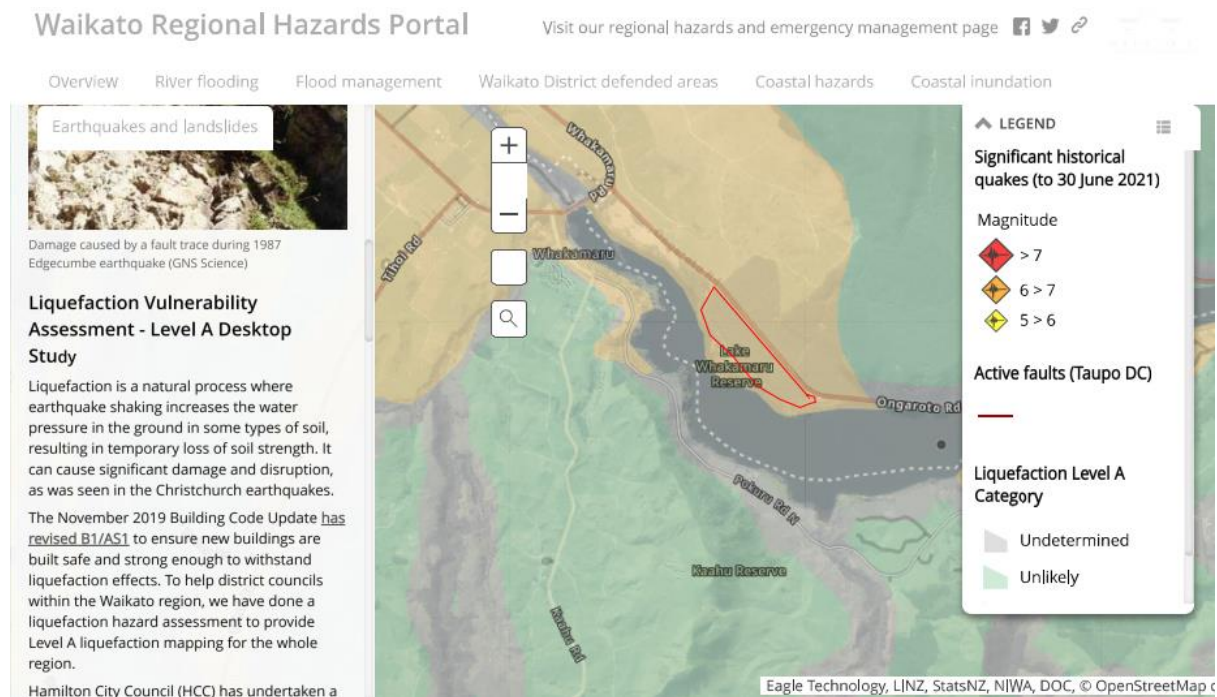
Waikato Regional Council have produced a ‘Level A’ liquefaction map for the region (Waikato Regional Hazards Portal, 2021). A copy of the map is presented in Figure 4. This shows that liquefaction at the site is considered “possible”.

**Figure 4: Waikato Regional Council Regional Hazards Portal – Liquefaction (site boundary outlined in ‘red’)**
