HD2430 – Lake Whakamaru Private Plan Change – HAIL assessment

Thank you for the opportunity to provide you with a HAIL assessment to help with your proposed private plan change for 1861 Ongaroto Road, Kinleith (the site).

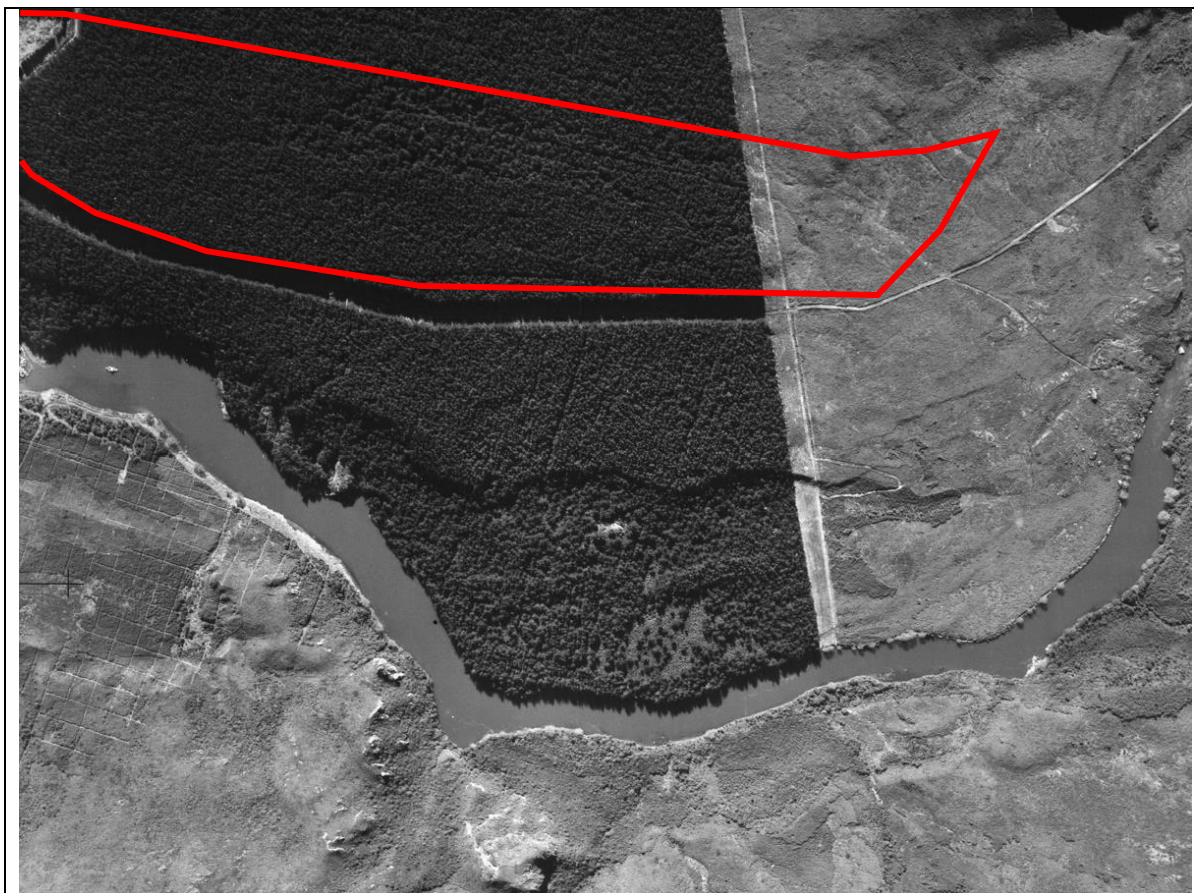
1946 (Retrolens, boundary is approximate)

Most of the site is an established forestry block in the earliest available aerial photo (1940), with vacant pasture located on the eastern portion of the site. It is bounded by forestry blocks to the north and south, vacant land to the north and east, and a road to the south. The Waikato River can be seen to the south of the site.

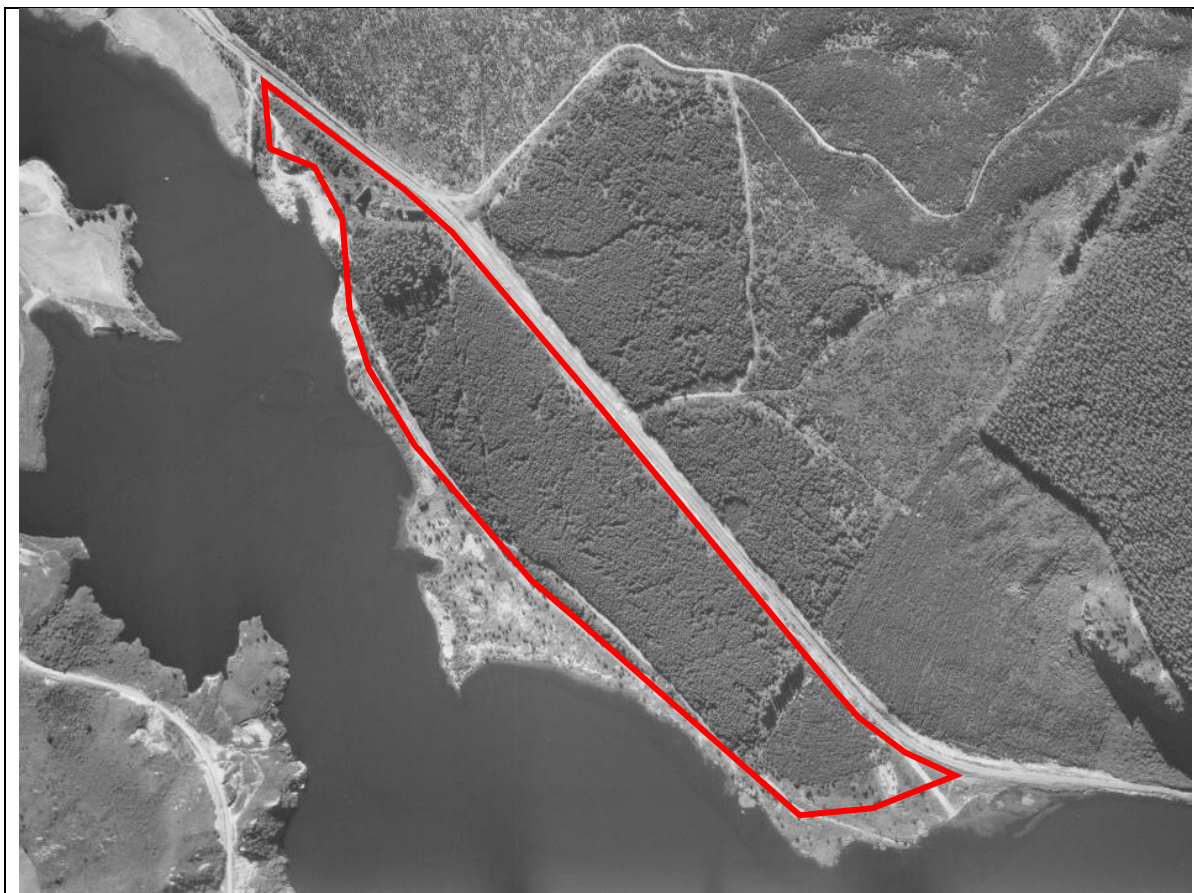
1963 (Retrolens, boundary is approximate)

Off-site, no significant changes can be seen until 1963, where a dam has been established resulting in the formation of Lake Whakamaru.

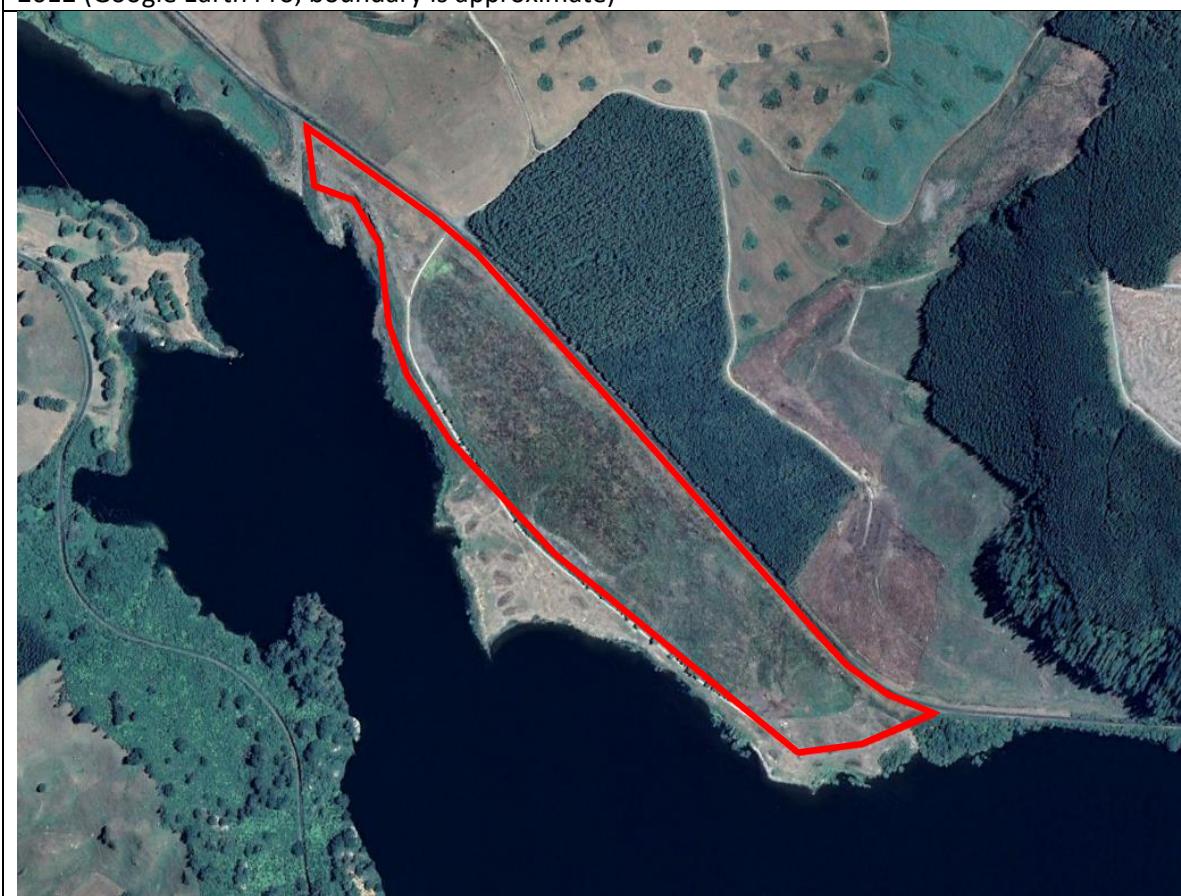
2021 (Google Earth Pro, boundary is approximate)

No significant changes can be seen onsite until 2019, where the trees on site have been harvested. The site has since been replanted.
