# LAND USE CAPABILITY REPORT

Ongaroto Road  
Subdivision, Whakamaru

PROJECT NO. C2131

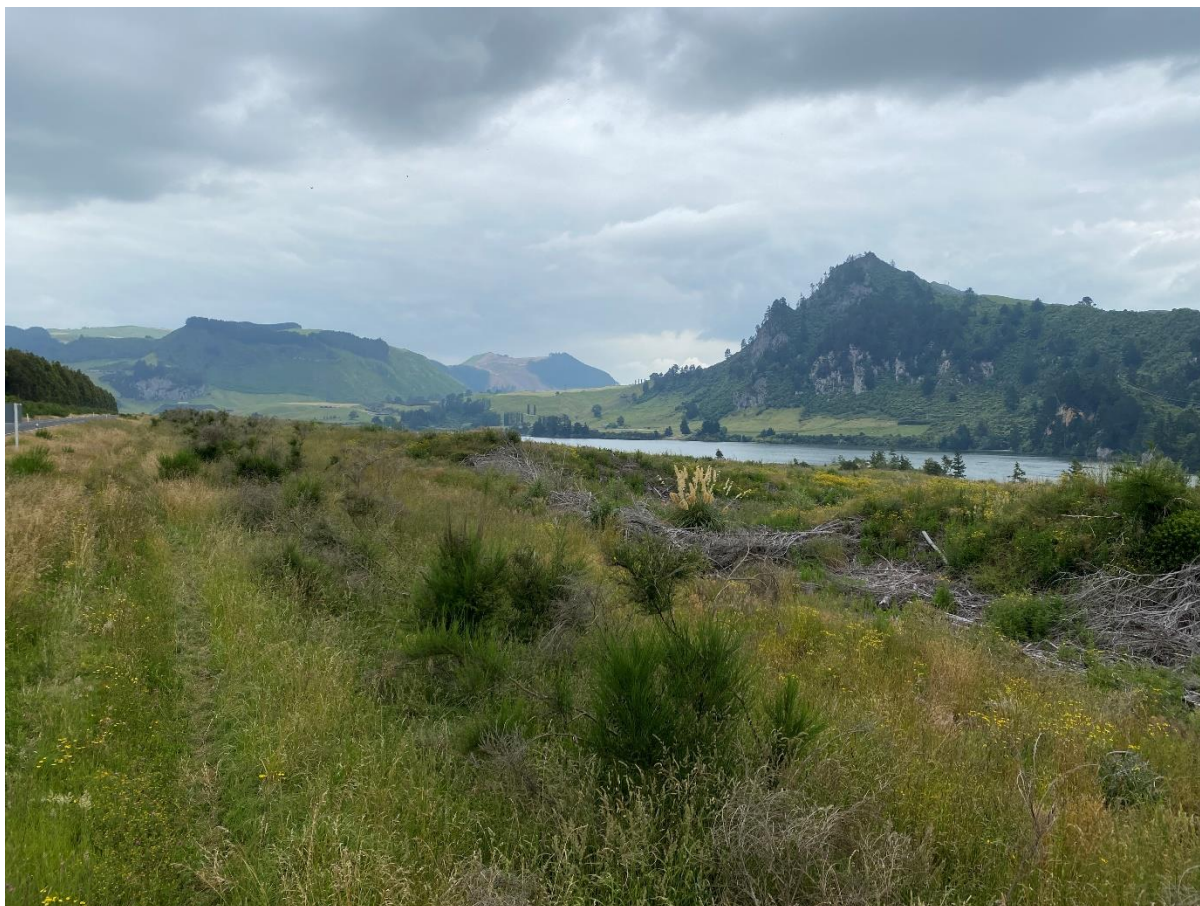
Figure 1: Site Photo

It is noted that on a second site walkover on the 12<sup>th</sup> of October 2022 much of the site had been cleared and new pine saplings had been planted. The clearing of the site highlighted areas used as skids for forestry and showed the metal at the surface. It also showed that at the surface in some locations are boulders and rock outcrops. The lower south-eastern portion of the site directly adjacent to the lake and local reserve had shown areas of recontouring.

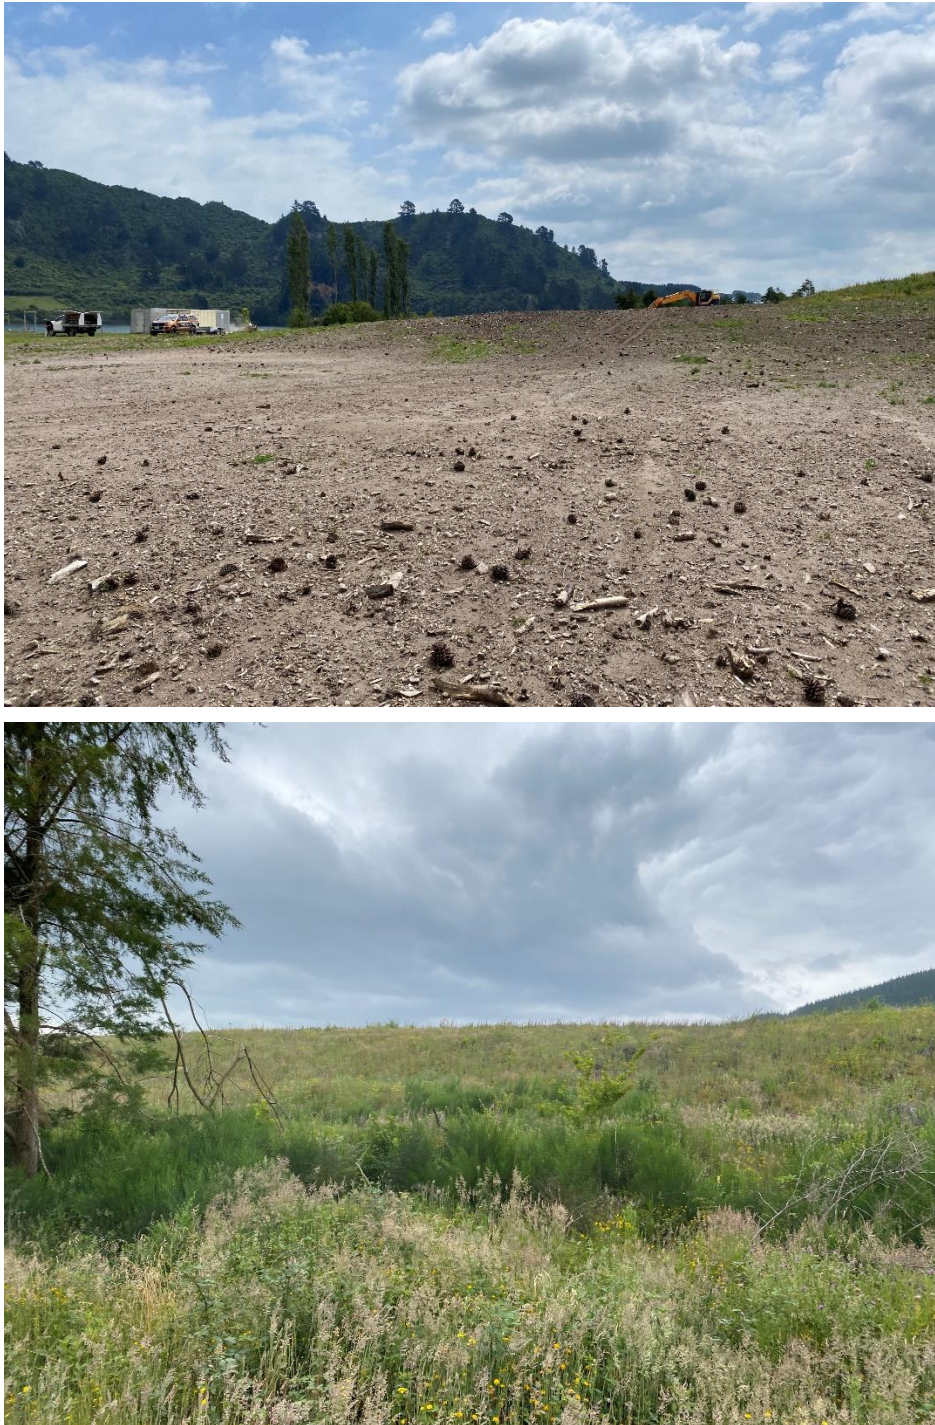
The topography of the site is generally sloping, with only small areas nearer the river where steep slopes are encountered. Much of the site is easily transversable, with the steep sections being the only areas where walking was not possible easily.

Figure 2: Several images of the site showing the general topography of the site.

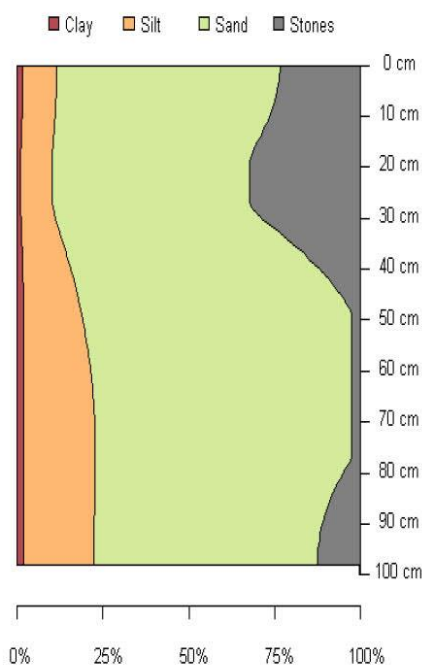
The values for the graphs above have been generated from horizon and pedotransfer data. These values have then been splined to create continuous estimates of soil water holding capacity and particle size distribution the soil profile. These curves express the particle size distribution and water retention of the soil however there may be barriers to rooting depth that are not necessarily represented in these properties directly. It is advisable to check the potential rooting depth and rooting barrier fields in the soil physical properties section on page three of this factsheet.
